INTEGRATING TERRA COTTA WINDOW MULLION REPAIR WITH LEADED STAINED GLASS WINDOW RESTORATION *at St. Dominic's Church, San Francisco*

by Lex F. Campbell; Simpson, Gumpertz, and Heger

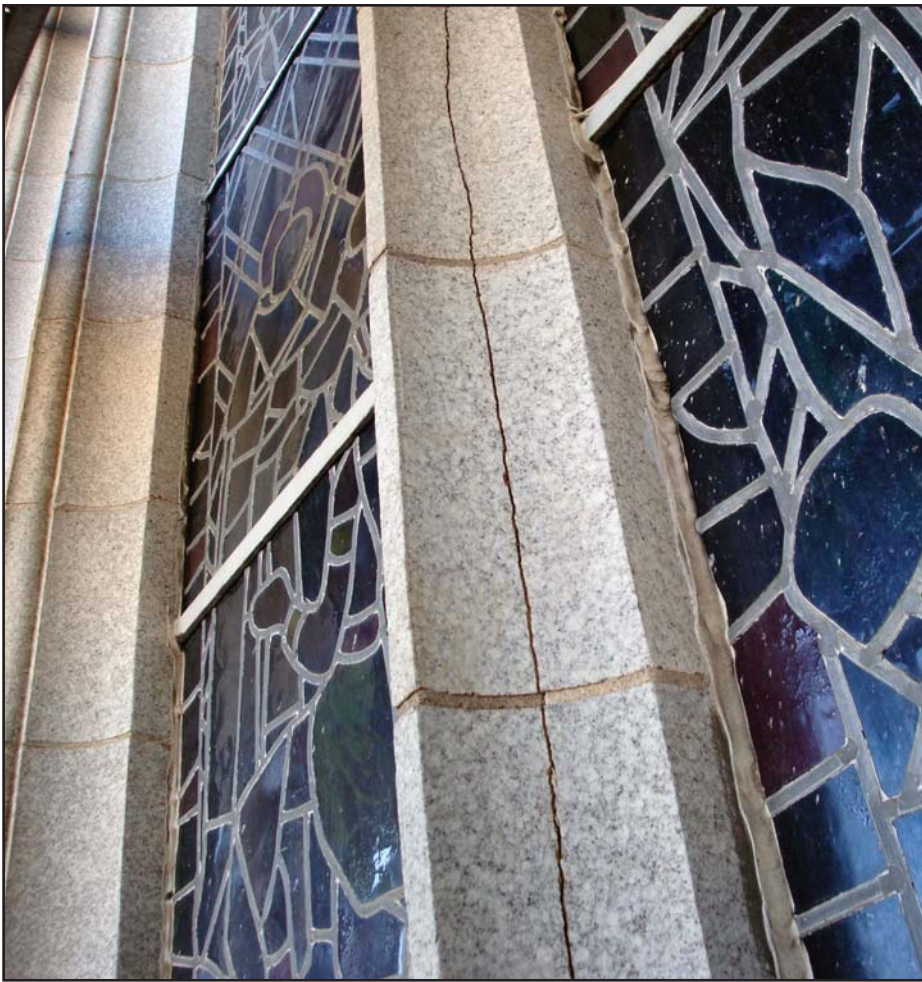
A vertical crack in a terra cotta mullion.

Physical investigations of cracked mullions and structural reinforcement by removing terra cotta blocks confirmed that corroded steel mullions were the problem. Pressure from flaking and expanding corroded steel caused the mullions to expand and crack. A likely cause of the corrosion was water leaking into the mullions from deteriorated window

Following the removal of the leaded glass windows for restoration, the terra cotta mullions were repaired. The terra cotta mullions are formed by stacked individual hollow terra cotta blocks filled with grout and supported by steel "tees." To repair the mullions, the terra cotta mullion blocks were disassembled, and cracked mullions were replaced. Where possible, intact mullion blocks were salvaged and reinstalled. The corroded supporting steel tees were removed and replaced with new stainless steel support tees and anchoring.

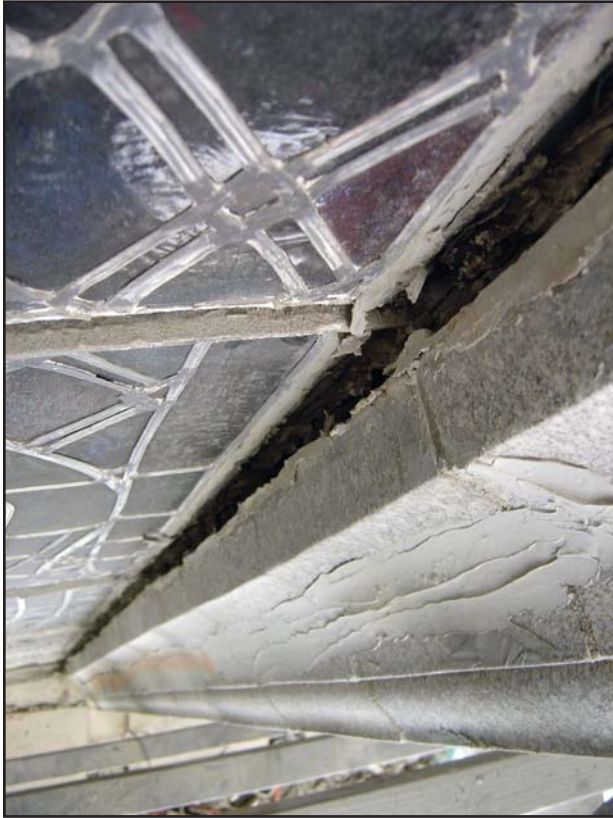
A window reglet or groove in poor condition.

frame or reglet was in poor condition. The hard cement and glazing putty used to set the windows were cracked and deteriorated, allowing water into the window frame and wall. Finally, all the setting materials, including some sealants, tested positive for the presence of asbestos fragments.

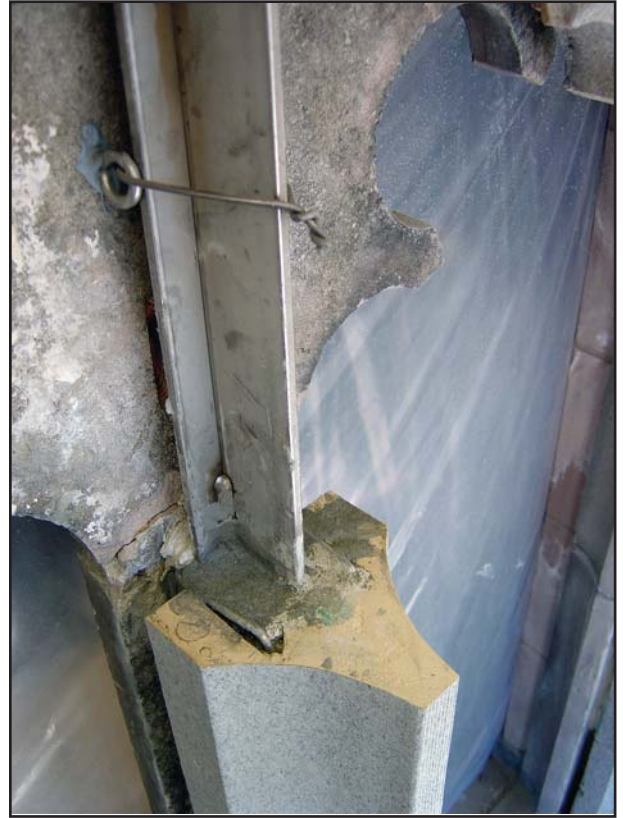
The installation of a new stainless steel "T" mullion and terra cotta blocks.

possible, stainless steel anchor plates were used to connect the ends of the steel mullions to the concrete wall structure. In other locations, the ends were embedded in grout-filled notches cut into the concrete wall opening at the sill or lintel. Stainless steel wires wound through the webbing connected the terra cotta mullion blocks to the steel tees. The entire mullion cavity finally was filled with masonry grout to provide additional structural stability.

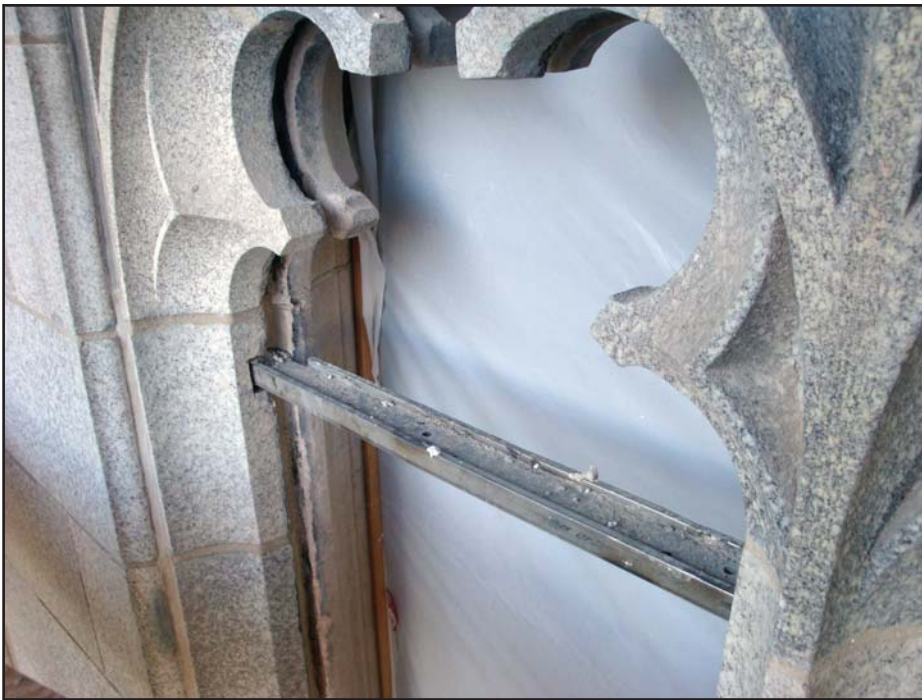
A stainless steel cross bar provides additional structural support.

In some cases, such as on some larger windows, the steel mullion was not sufficient to meet code requirements in order to withstand wind loads. At these windows, an H-shaped steel cross bar was used to connect the mullion to the window jambs, providing additional lateral support. Because the cross bar was

exposed, there was a visual impact on the window with the introduction of a horizontal element. To minimize the impact, the horizontal bar was located between the leaded glass panels in individual lancets, replacing the bronze tee that would normally provide horizontal support. Because the cross bar was thicker than a typical tee bar, adjustments were necessary in the overall vertical alignment of the lancet panels. The panel located above the horizontal bar was raised slightly to maximize the visibility of the glass design.

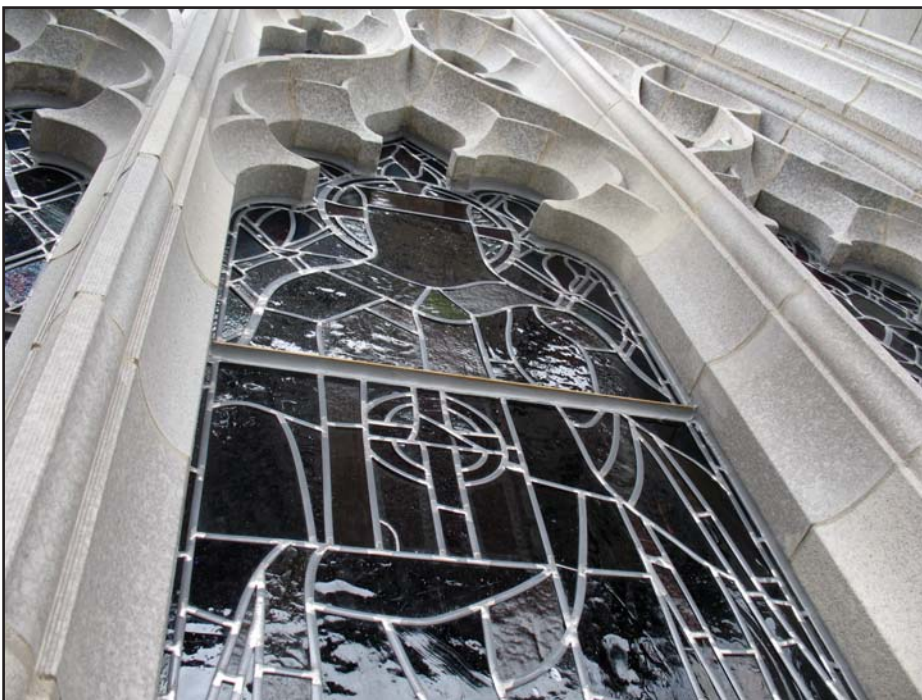
A lancet window with a new perimeter sealant joint.

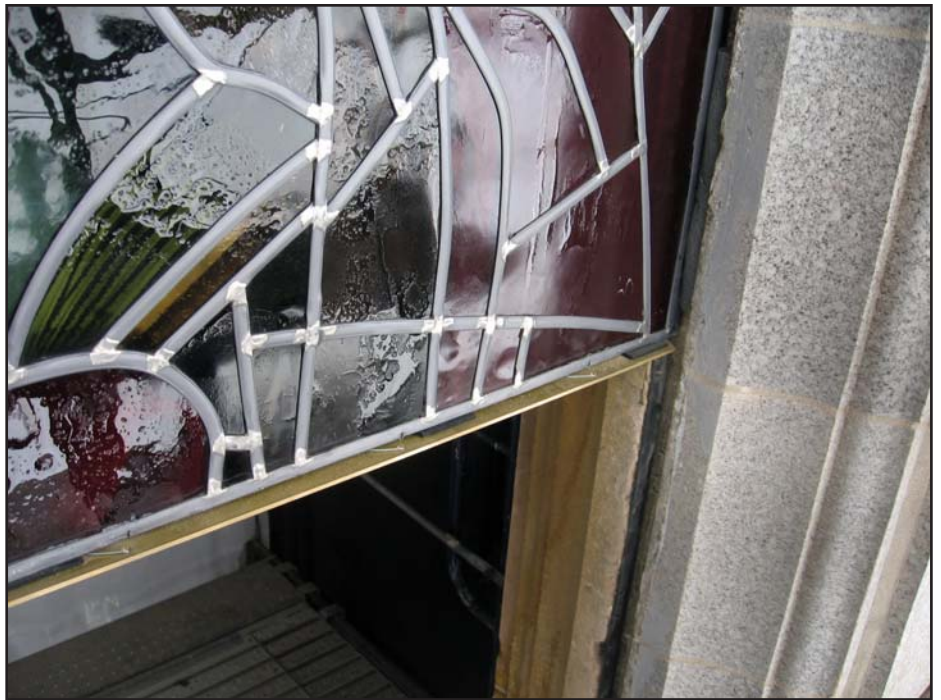
Exterior detail of new tee bar installation.

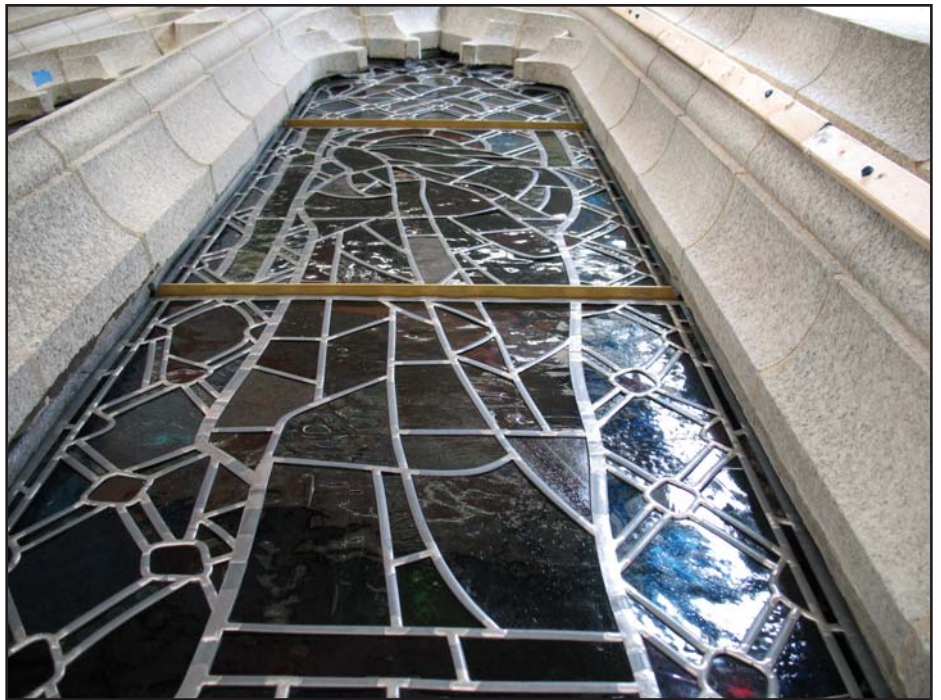
A lancet window with new brass tee bars.

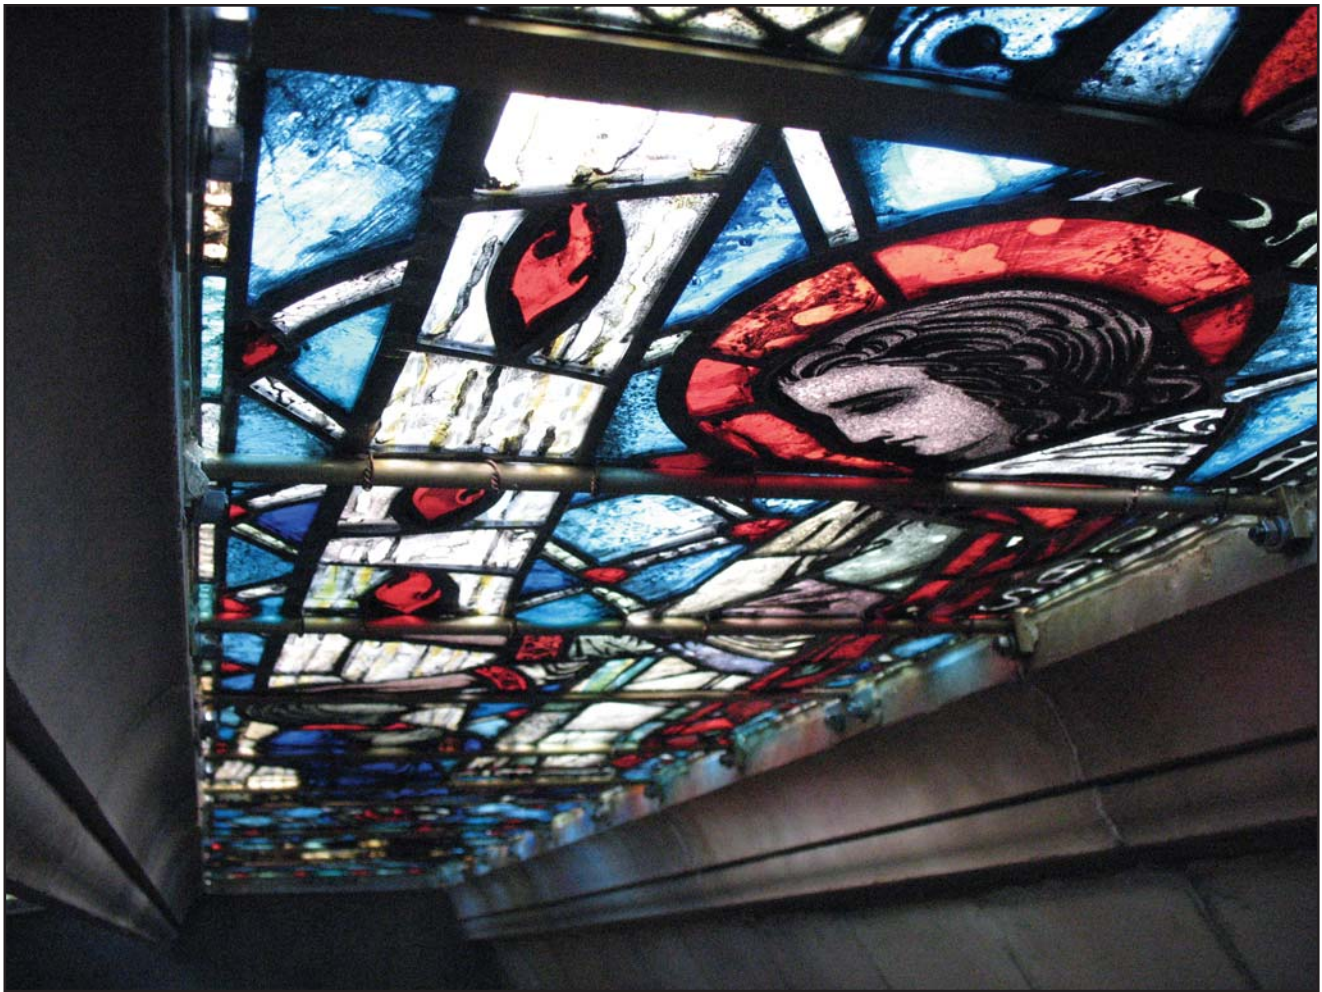
Interior of lancet panel showing brass round bars.
